**STEREOMICROSCOPE INSPECTION OF POLISHED ALUMINUM COLLECTOR 50684.0.** M. C. Rodriguez<sup>1</sup>, M. J. Calaway<sup>2</sup>, J. H. Allton<sup>3</sup>, <sup>1</sup>Geocontrol Systems- ESCG at NASA/Johnson Space Center, Houston, TX 77058; [melissa.rodriguez-1@nasa.gov](mailto:melissa.rodriguez-1@nasa.gov), <sup>2</sup>Jacobs- ESCG at NASA/Johnson Space Center, Houston, TX 77058, <sup>3</sup>NASA/Johnson Space Center, Houston, TX 77058.

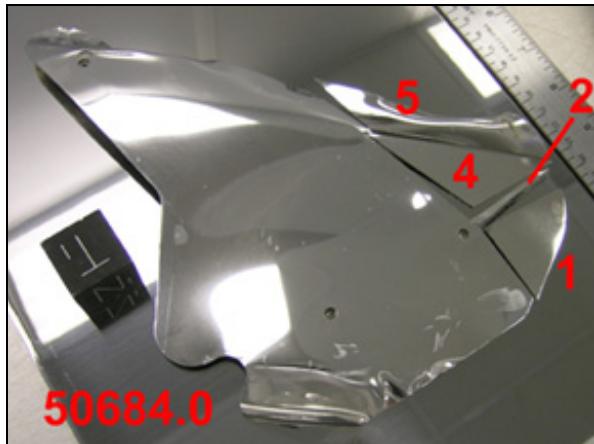
Fig. 1. Polished aluminum collector after subdivision in 2005. Portions 1, 2, 4, and 5 were previously imaged. Imaging of portion 50684.0 is in progress.

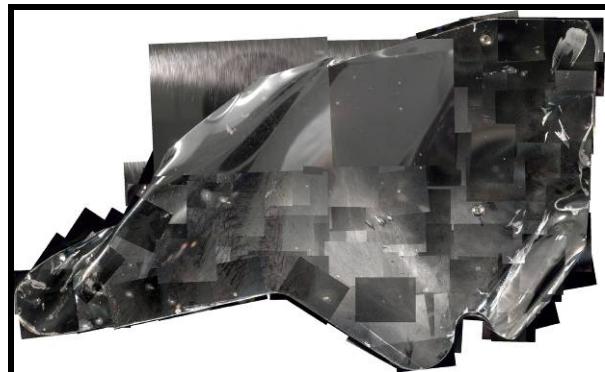
Fig. 2. Overview image of remaining polished aluminum kidney, 50684.0.

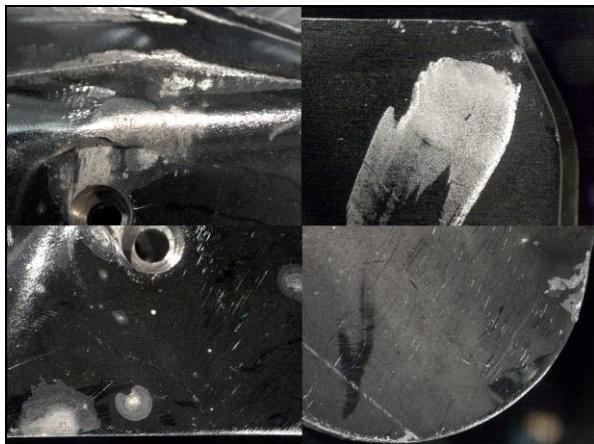
**Stereomicroscope Observations:** Post-flight characterization shows that the collector area has remained intact and did not fracture during impact. However, the Al collector was distorted and bent from the original dimensions. Mud and salt evaporite contamination from the Utah lakebed landing site is observed on the outer edges of the collector (Fig. 3) in smears and dried droplet formations. An extremely fine layer of particulate contamination is also present on the interior, flatter portions of the collector, recording evidence of physical movements of fragments during the hard landing (Fig. 4). Examples of hypervelocity impact craters, found on the right-hand portion of the image, are shown at higher magnifications in Fig. 5. All of the crater shapes appear to be uniformly round diameters at the collector surface and have unevenly splayed protruding edges. The interior “pit” bases also appear to be consistently rounded. Various gouges and scrapes from the hard landing have also been imaged; these are markedly different from impact cratering features and also appear near collector edges (Fig. 6).

Fig. 3. Four examples of Utahogenic contamination near collector edges at 0.63X.

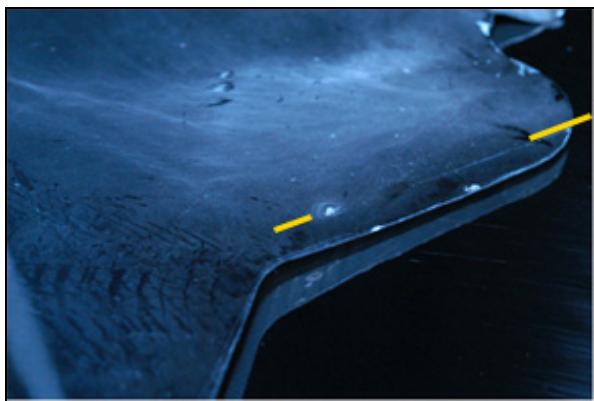
Fig. 4. Patterns in extremely fine material coating the polished surface shows evidence of physical movement of fragments during hard landing.

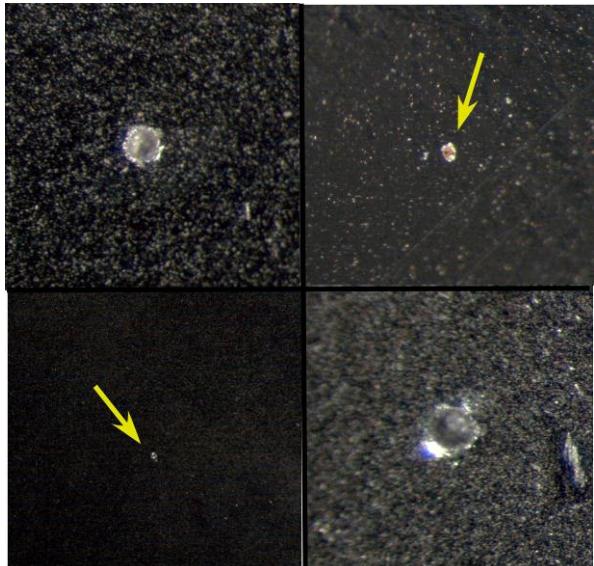
Fig. 5. Examples of microcraters on polished aluminum surface. Image on lower left has not been positively identified.

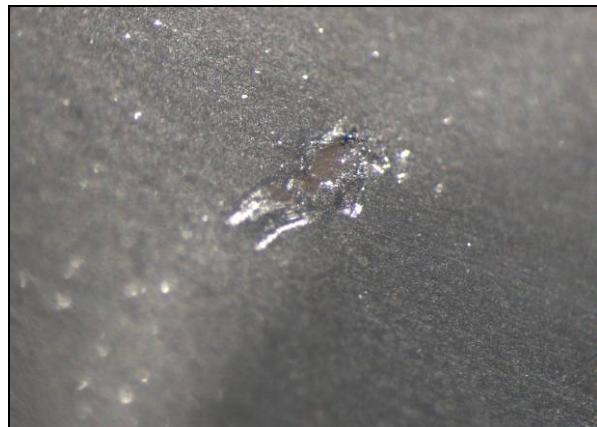
Fig. 6. Irregularly shaped gouge on aluminum kidney surface.
